**Pre-Renovation Asbestos and Lead Survey
302 22nd Street
Virginia Beach, VA 23451**

**City of Virginia Beach
Municipal Center – Building 23
2473 N. Landing Road
Virginia Beach, VA 23456
ATTN: Mr. Mike Bumbaco, P.E.**

Date: November 3, 2021

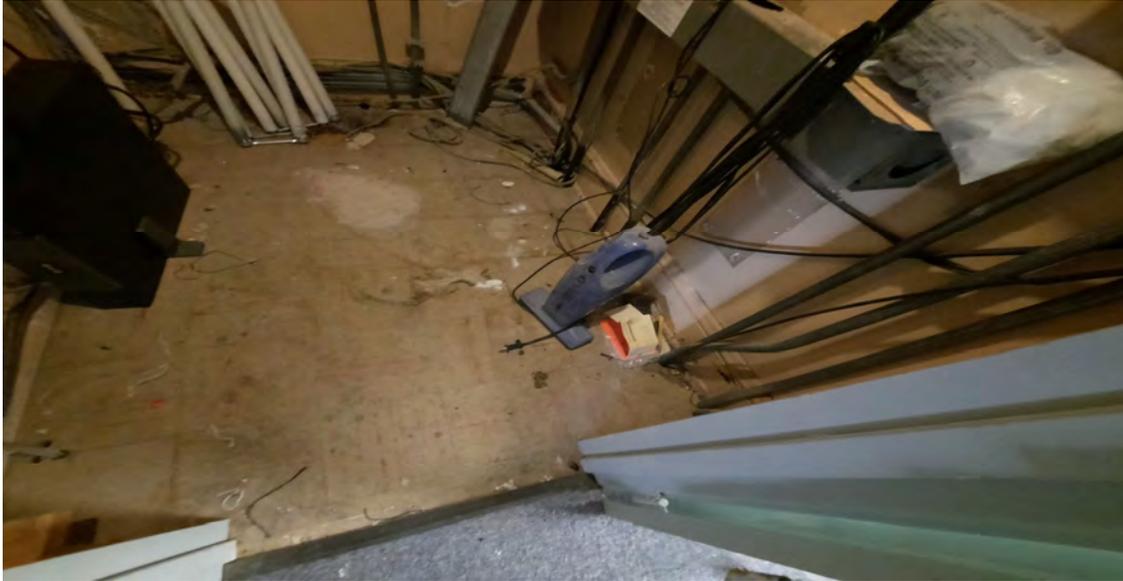
9" Gray floor tile and mastic (Equipment Room/top layer)

Photograph 3: View of non-friable asbestos-containing 9" gray floor tile and mastic (top layer), located in the 1st Floor Equipment Room of the subject property (Samples 35 and 36).

Floor tile and mastic are considered Category I non-friable ACM. Removal of Category I non-friable ACM is not required, prior to renovation, if the material is not going to be disturbed during planned renovation. Wet methods must be used during the renovation activities where identified ACM are to be disturbed. Additionally, all associated renovation debris must be considered asbestos containing and be taken to a landfill that accepts Category I non-friable ACM. However, the contractor may have the option of removing all ACM prior to renovation, which would allow the balance of the renovation debris to be classified as regular construction waste, therefore allowing recycling.

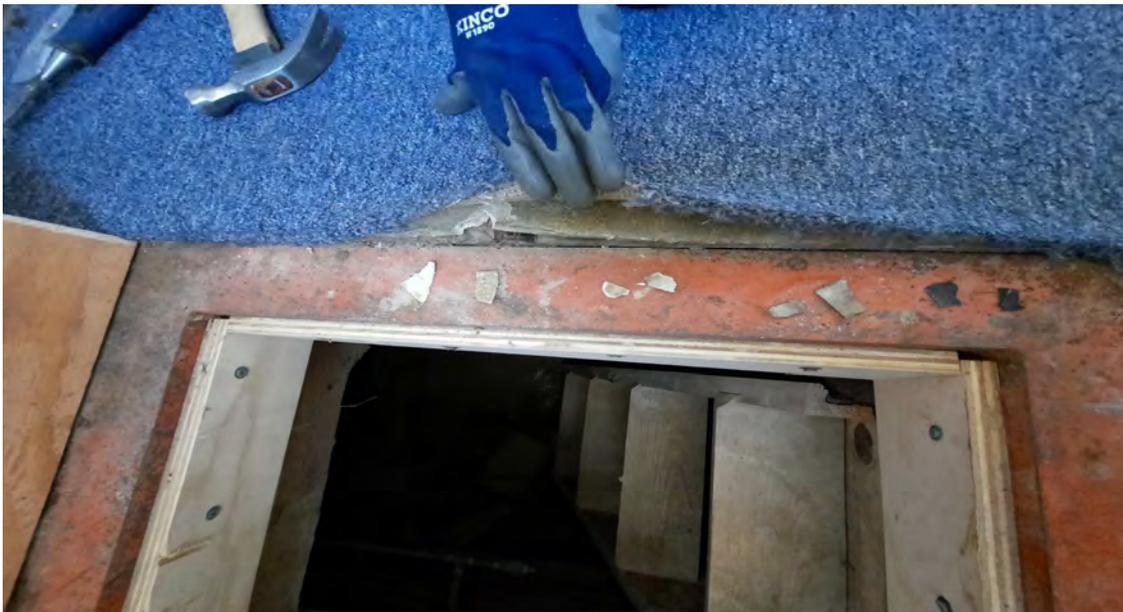
Gray floor tile (Kitchen/middle layer)

Photograph 4: View of non-friable, asbestos-containing gray floor tile (middle layer), located in the 1st Floor Kitchen of the subject property (Samples 45 and 46).

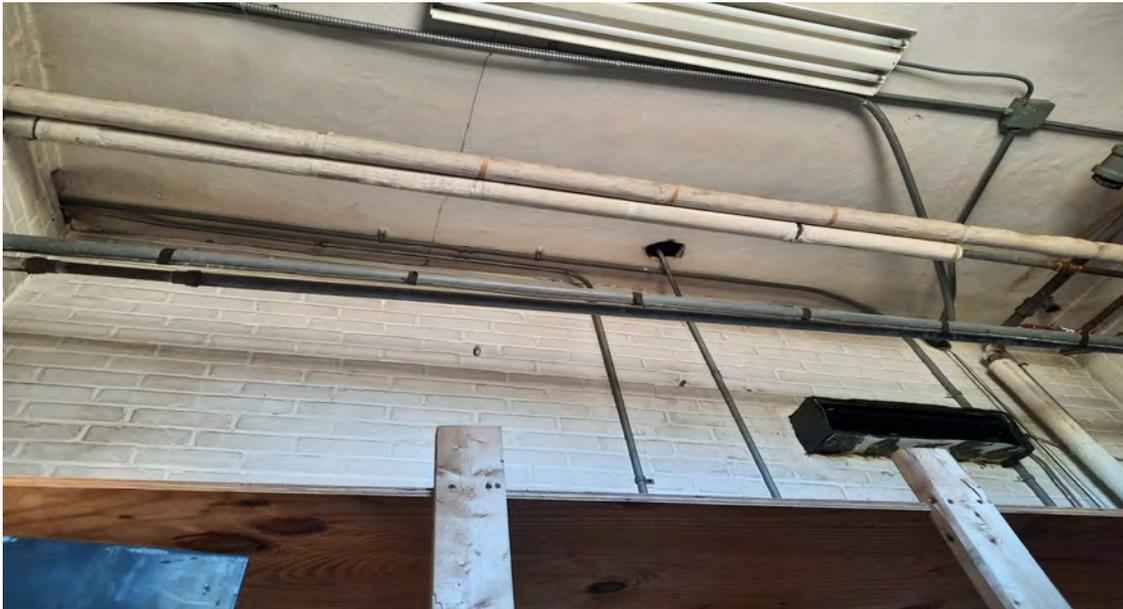
White pipe lagging and insulation (Boiler Room)

Photograph 5: View of friable asbestos-containing white pipe lagging and insulation in the 1st Floor Boiler Room of the subject property (Samples 67-70).

Pipe lagging and insulation are considered friable asbestos containing Thermal System Insulation under NESHAP. Under NESHAP, all friable ACM or material that may become friable must be removed if it will be disturbed during the renovation activities. These materials include pipe lagging and insulation, identified in the 1st Floor Boiler Room and in the Basement of the subject property. Abatement will require a negative air enclosure, critical barriers, project monitoring and disposal of waste materials at a landfill that accepts friable asbestos.

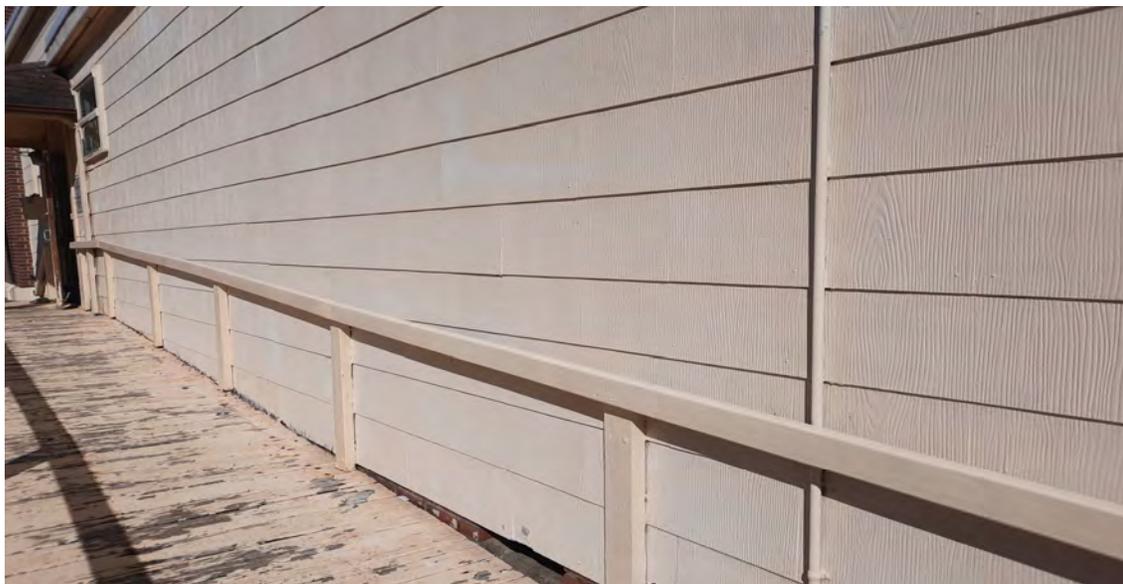
Gray siding (Exterior)

Photograph 6: View of non-friable asbestos-containing gray siding, located on the 1st Floor exterior of the subject property (Samples 83 and 84).

Siding is considered Category II non-friable ACM. Removal of Category II non-friable ACM is not required, prior to renovation, if the material is not going to be disturbed during planned renovation. Wet methods must be used during the renovation activities where identified ACM are to be disturbed. Additionally, all associated renovation debris must be considered asbestos containing and be taken to a landfill that accepts Category II non-friable ACM. However, the contractor may have the option of removing all ACM prior to renovation, which would allow the balance of the renovation debris to be classified as regular construction waste, therefore allowing recycling.

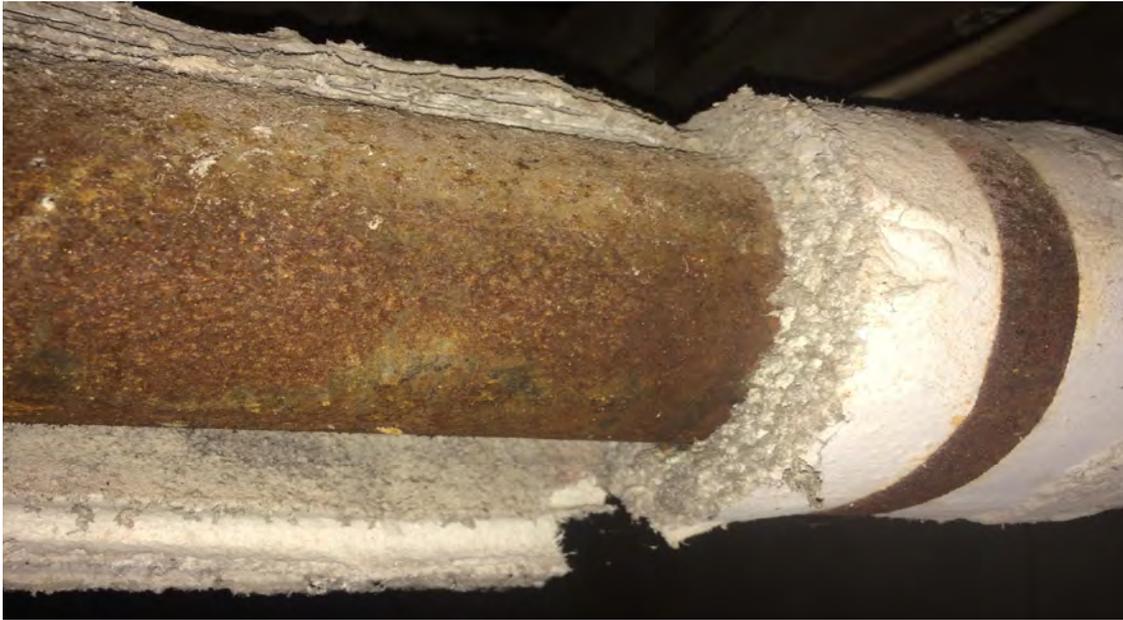
White pipe insulation

Photograph 7: View of friable asbestos containing pipe insulation in the Basement of the subject property (Samples 87 and 88).

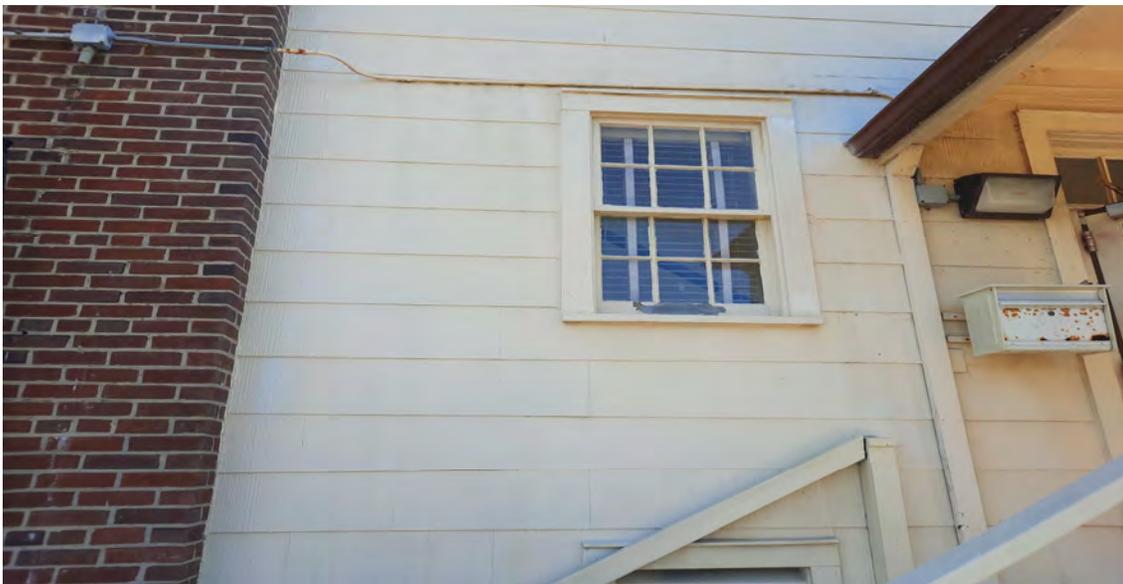
Cream window paint (1st Floor Exterior West Window)

Photograph 8: View of lead-based cream window paint, located on the 1st Floor Exterior W Window of the subject property (Sample 1).

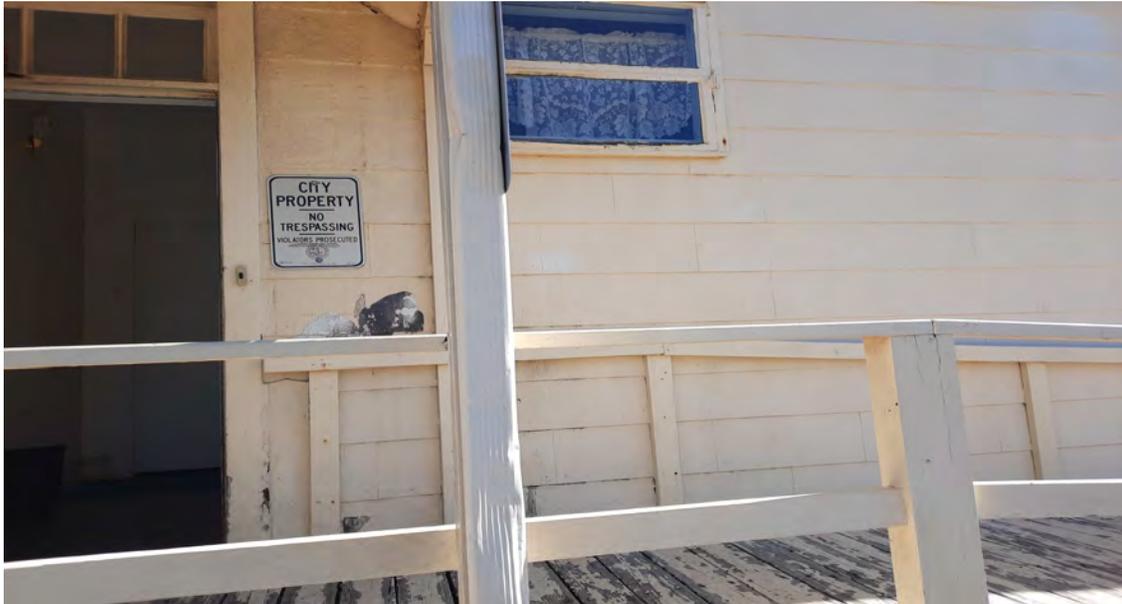
Cream siding paint (1st Floor Exterior West Siding)

Photograph 9: View of lead-containing cream siding paint, located on the 1st Floor Exterior W side of the subject property (Sample 3).

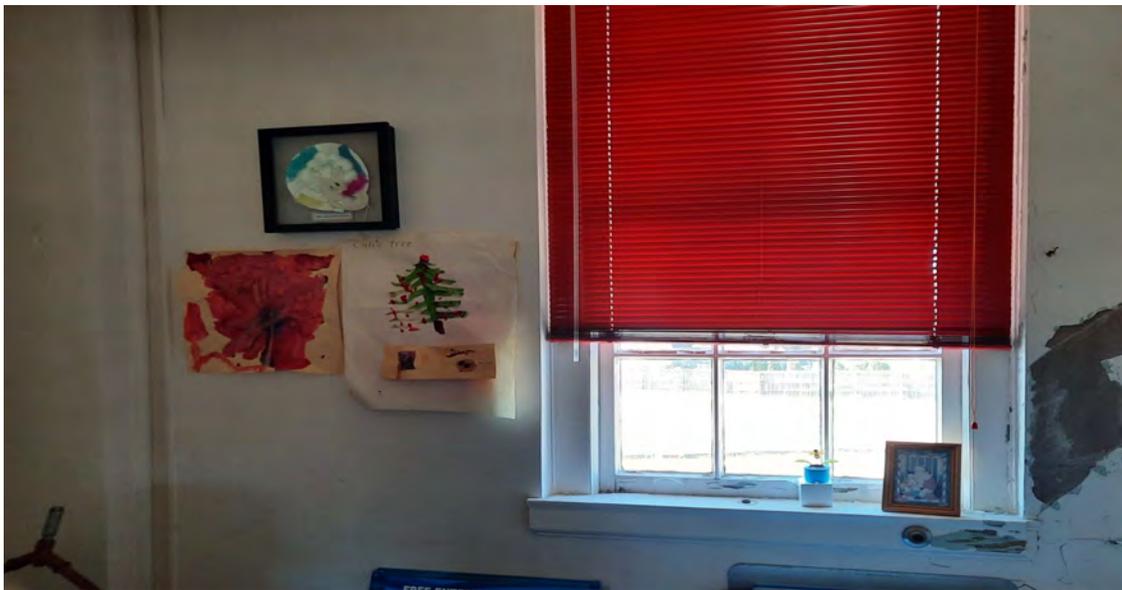
Off-white wall paint (2nd Floor Interior SW Office)

Photograph 10: View of lead-containing off-white wall paint, located in the 2nd Floor Interior SW Office of the subject property (Sample 4).

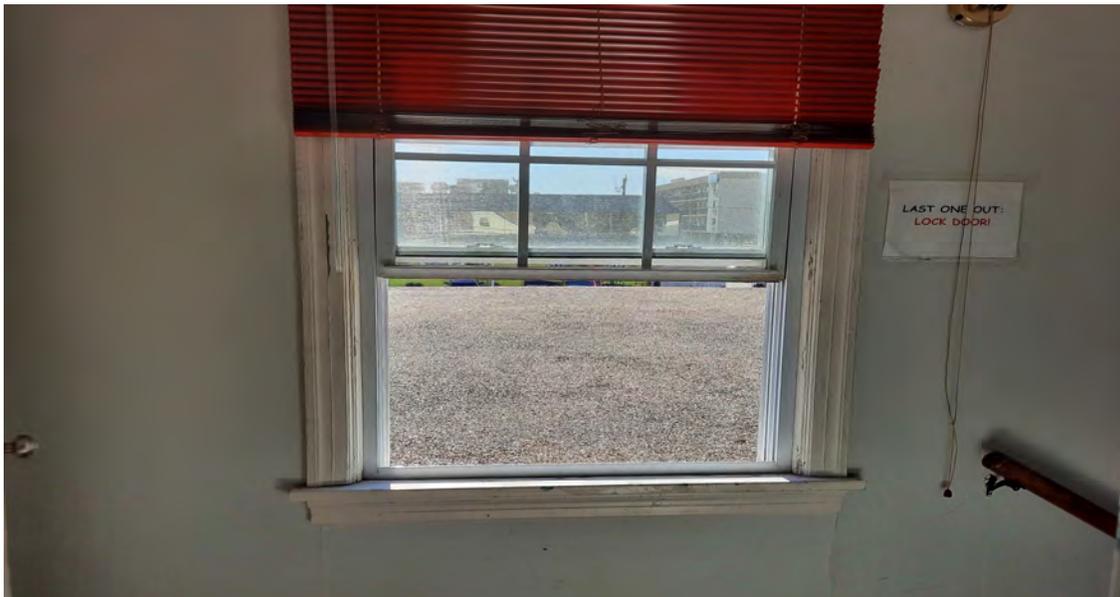
White window paint (2nd Floor Interior Stairwell Window)

Photograph 11: View of lead-based white window paint, located on the 2nd Floor Interior Stairwell Window of the subject property (Sample 5).

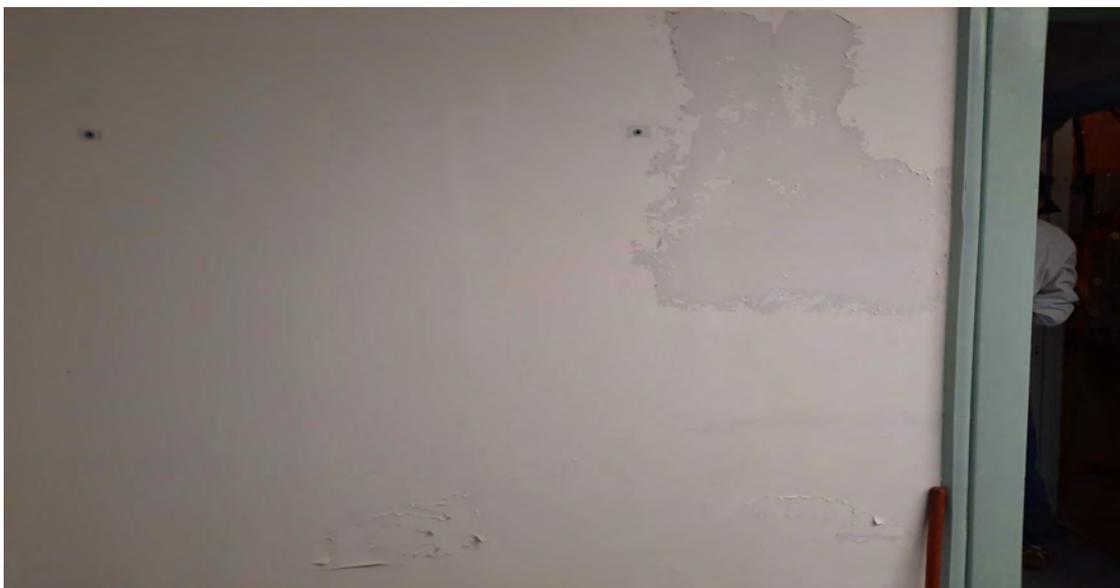
White wall paint (1st Floor Interior Wall)

Photograph 12: View of white wall paint with detectable lead, located on the 1st Floor Interior Wall of the subject property (Sample 6).

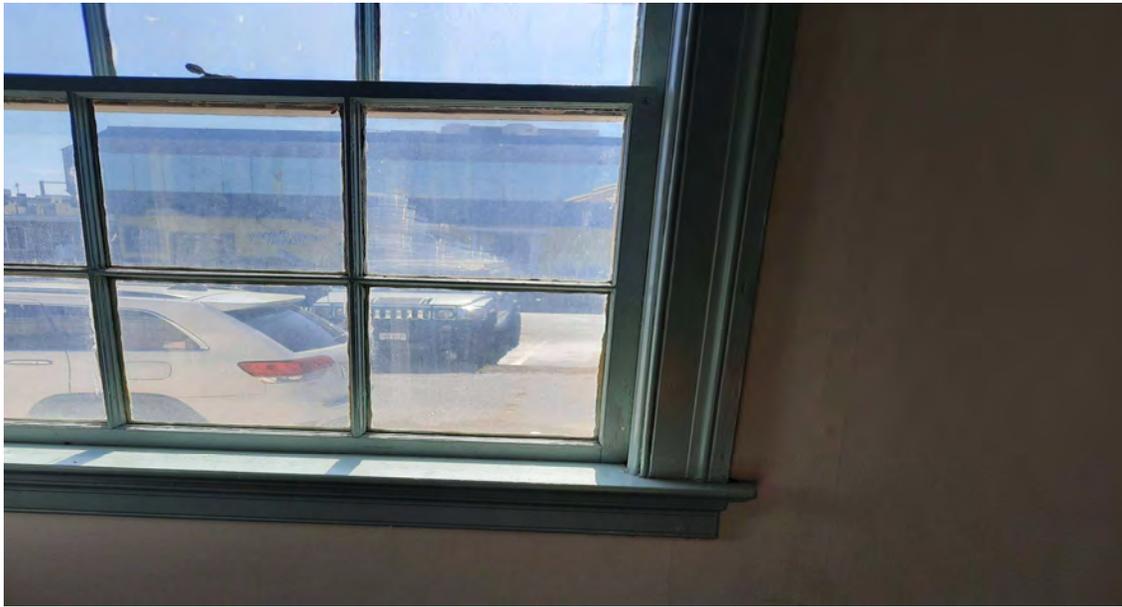
Green window trim paint (1st Floor Interior S Room)

Photograph 13: View of lead-based green window trim paint, located in the 1st Floor Interior S Room of the subject property (Sample 7).

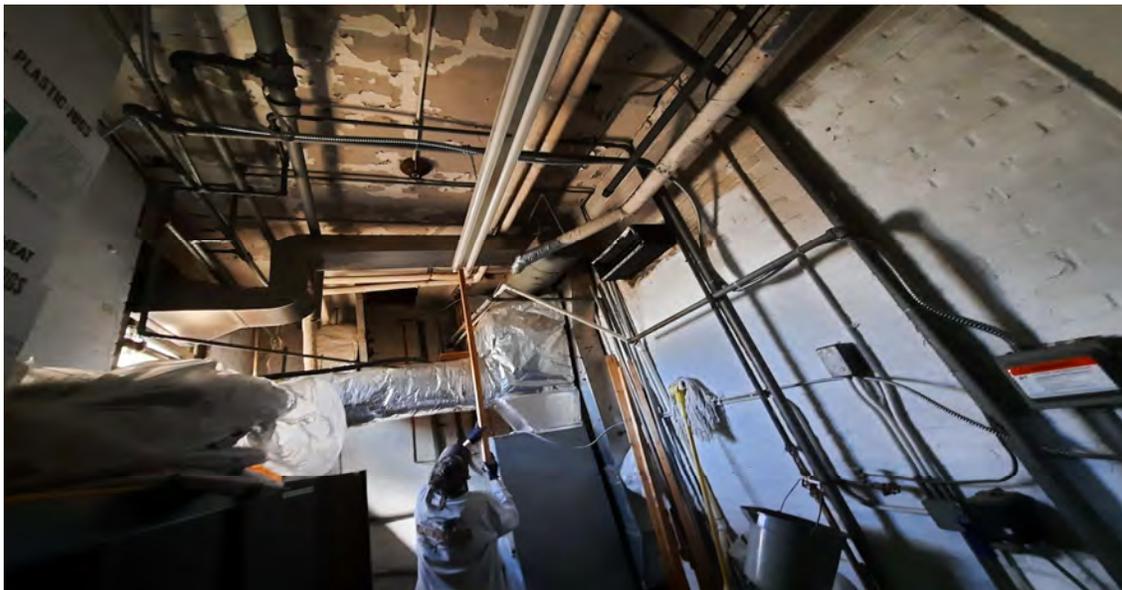
White wall paint (1st Floor Interior Boiler Room)

Photograph 14: View of lead-containing white wall paint, located in the 1st Floor Boiler Room of the subject property (Sample 8).
